VERIFICATION OF THE MATERIAL PROPERTIES OF THE STRUCTURE ELEMENTS OF COMPRESSOR STATION FOR THE NEEDS OF THEIR REDESIGN

Received – Prispjelo: 2014-04-28
Accepted – Prihvaćeno: 2014-09-25
Preliminary Note – Prethodno priopćenje

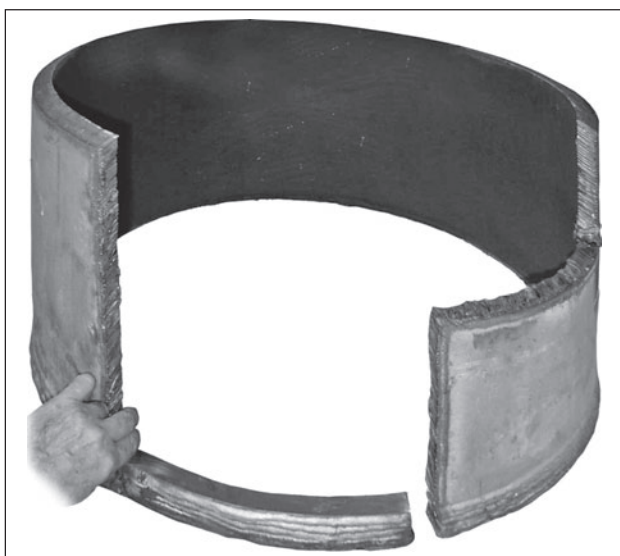
Mechanical properties and analysis of used construction material were determined by tests on corresponding specimens. These were acquired from a pipe section 720 x 22,2 mm, as shown in Figure 2. The piping ring was removed above a T-module ring – an inter-pressure turn to a turbocompressor, as shown in Figure 3.

Figure 2 Piping part as source of specimens used in material tests

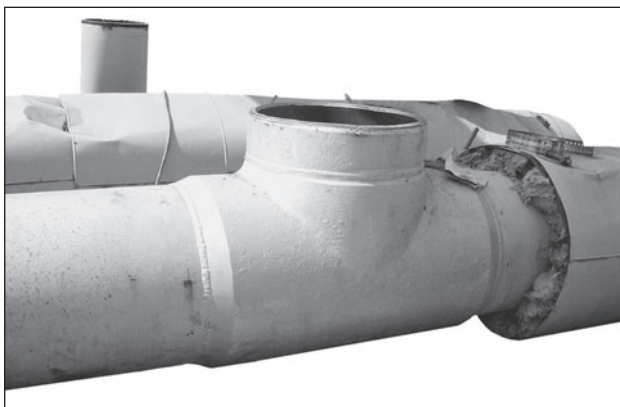
Figure 3 T-module ring – an inter-pressure turn to a turbocompressor

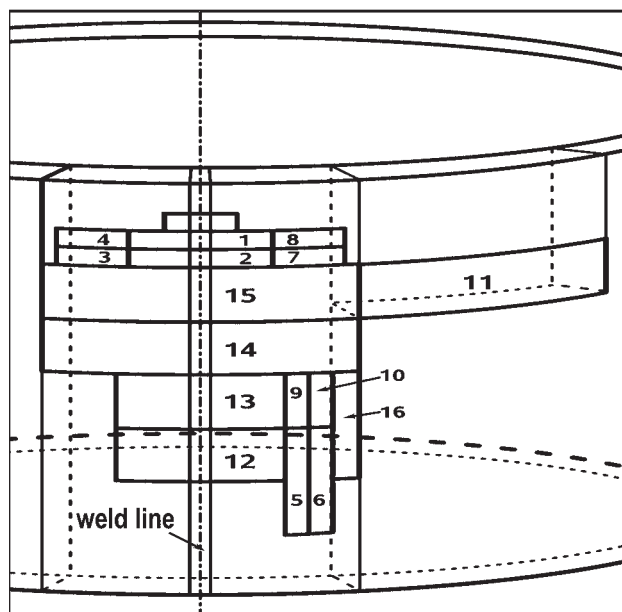
Figure 4 Identification of location of the specimens used in individual material tests

Sampling was done so that quantitative data about the properties of base material, material of welding metal and transition area of the weld could be determined. Figure 4 illustrates the identification of location of the specimens used in individual material tests. Performed were static tensile tests of the welding joint in direction perpendicular to the pipe axis and of the base material in direction perpendicular as well as parallel with the pipe axis. In addition, dynamic tests by impact in bending with type Charpy V notch, tests of fatigue properties in tension and bending of the base material and the welding joint.

For the fatigue properties tests specimens were removed from the detached ring from location 11 and specimens containing weld from locations 12, 13 for test by flat bending and from locations 14 and 15 for tensile tests (Figure 4). Shape and size of the test specimens were selected so that the transition area of the weld was located in the thinnest part of the specimen. Tests were performed on a testing pulsator, which allowed dynamic tests during alternating symmetrical bending at loading up to 400 Nm. In first stage of the tests stress amplitudes $\sigma_a = 240$ MPa were selected. In this mode, specimens remained undisturbed even at $2,6 \times 10^6$ cycles. In second stage, the amplitude was increased to level $\sigma_a = 450$ MPa, which for given material already represents an area of low-cycle fatigue. Specimens failure occurred at level 8×10^3 cycles, with the shape of fatigue fracture according to Figure 6. Fatigue crack initiated at the edge of the test specimen according to Figure 7, in location of welding joint imperfection. Nature of the fracture line is illustrated on Figure 8

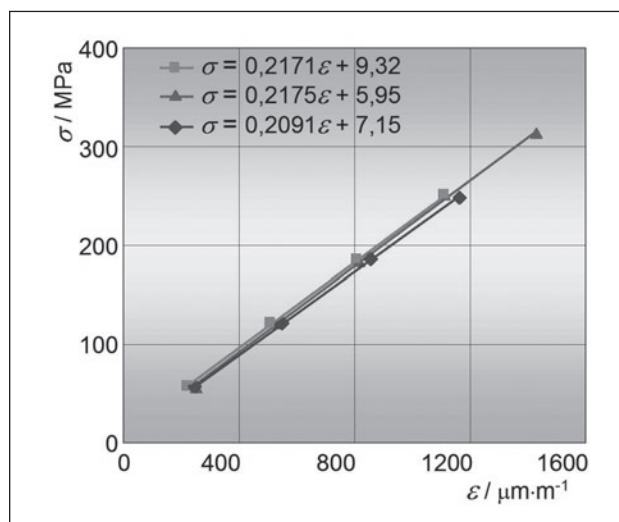
Results of the tests for modulus of elasticity are shown in Figure 5. These were acquired by experimental measurement using strain gages and testing machine

Figure 5 Experimentally acquired relationships for determination of modulus of elasticity E of the piping material

on a specimen similar to the one used in tensile test, removed from the ring in location 16 (Figure 4).
